# United States Fire Administration

## Technical Report Series

### Four Firefighters Die in Seattle Warehouse Fire Seattle, Washington

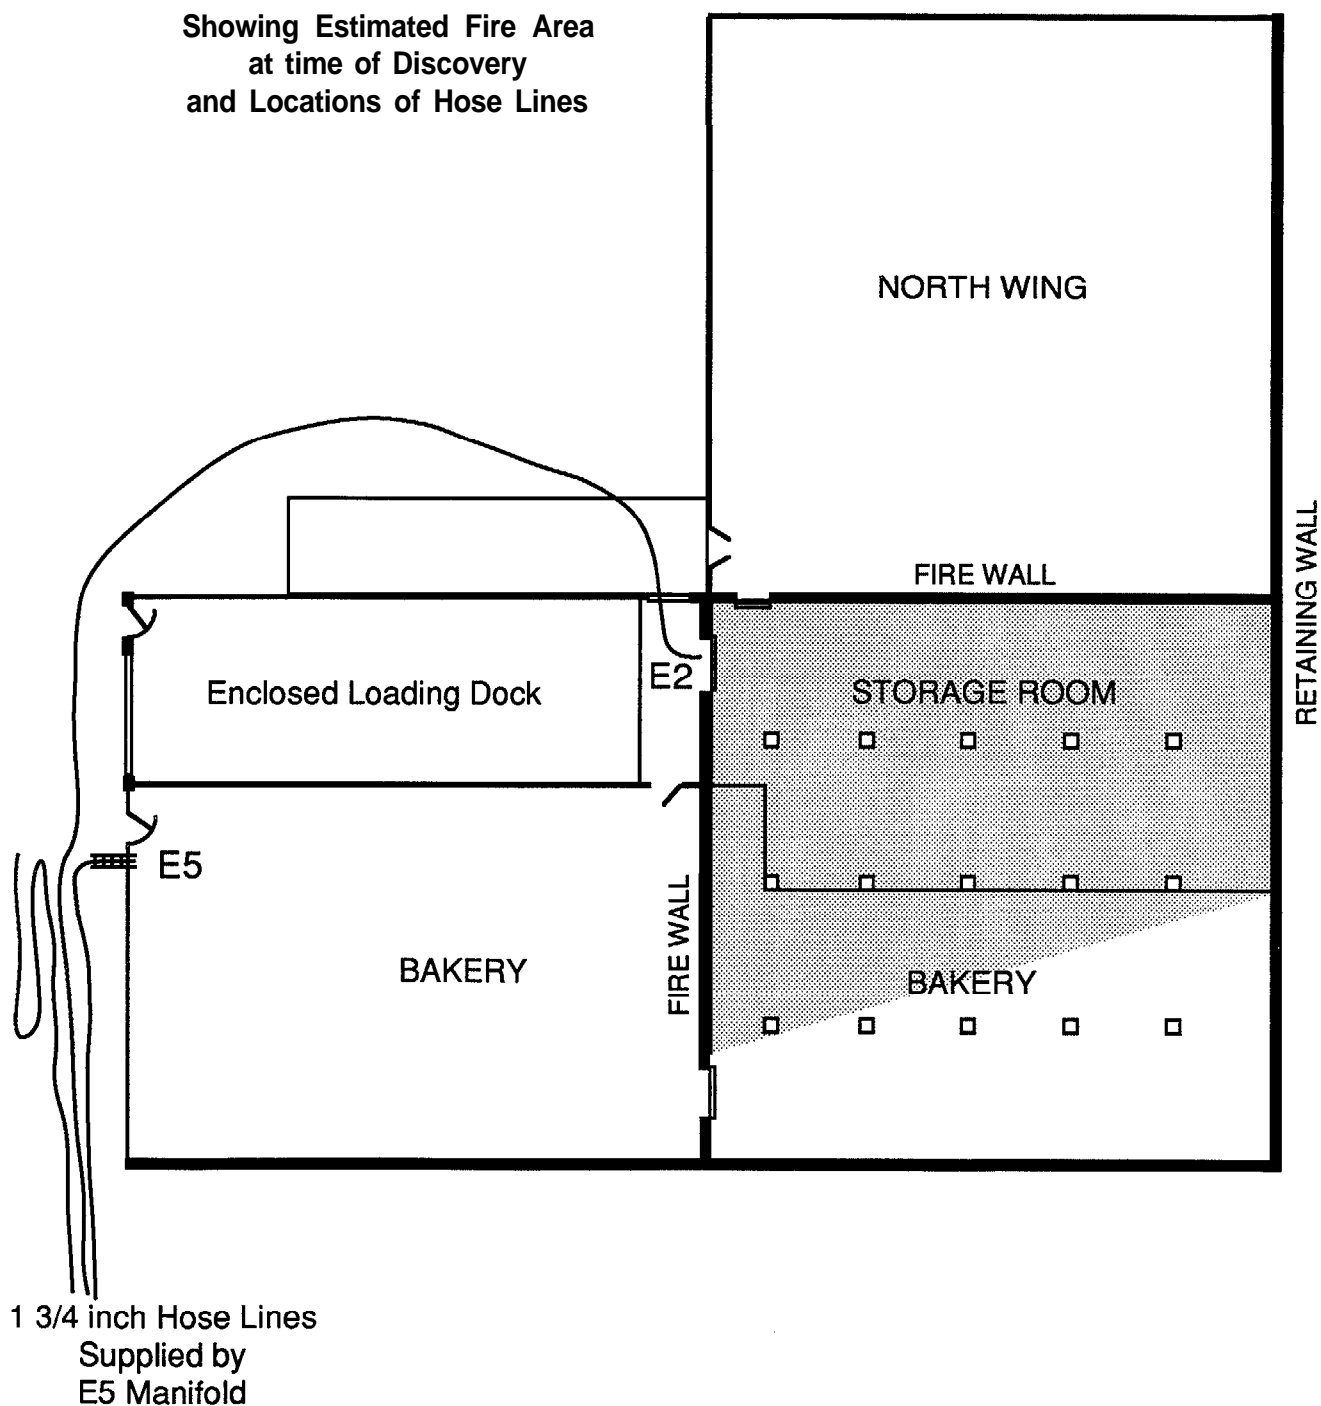
Figure 4

When they reached the loading dock they found the sliding fire door leading into the storage room partially open. The interior of the storage room was fully involved in fire; however, no smoke or flames were coming out of the doorway. The large fire was drawing air in through this opening. (This location is shown in Figure 4.)

Showing Estimated Fire Area  
at time of Discovery  
and Locations of Hose Lines

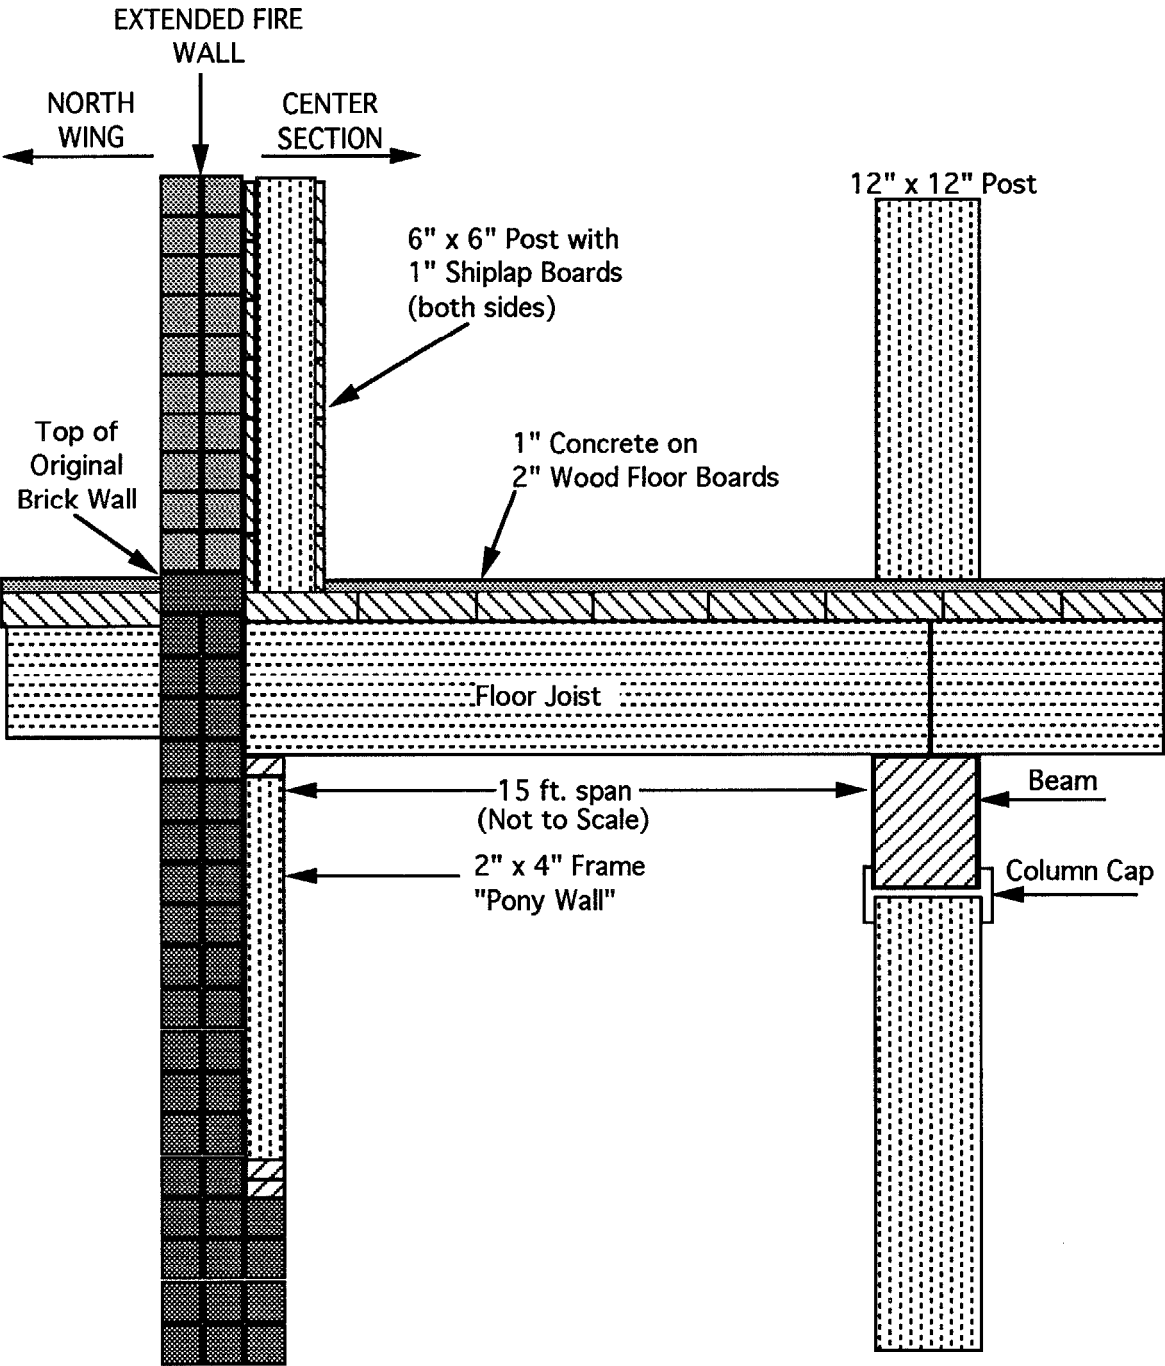
Figure 7

**CONSTRUCTION DETAILS  
AT INTERIOR FIRE WALL**  
(ALL DIMENSIONS ARE ESTIMATES)

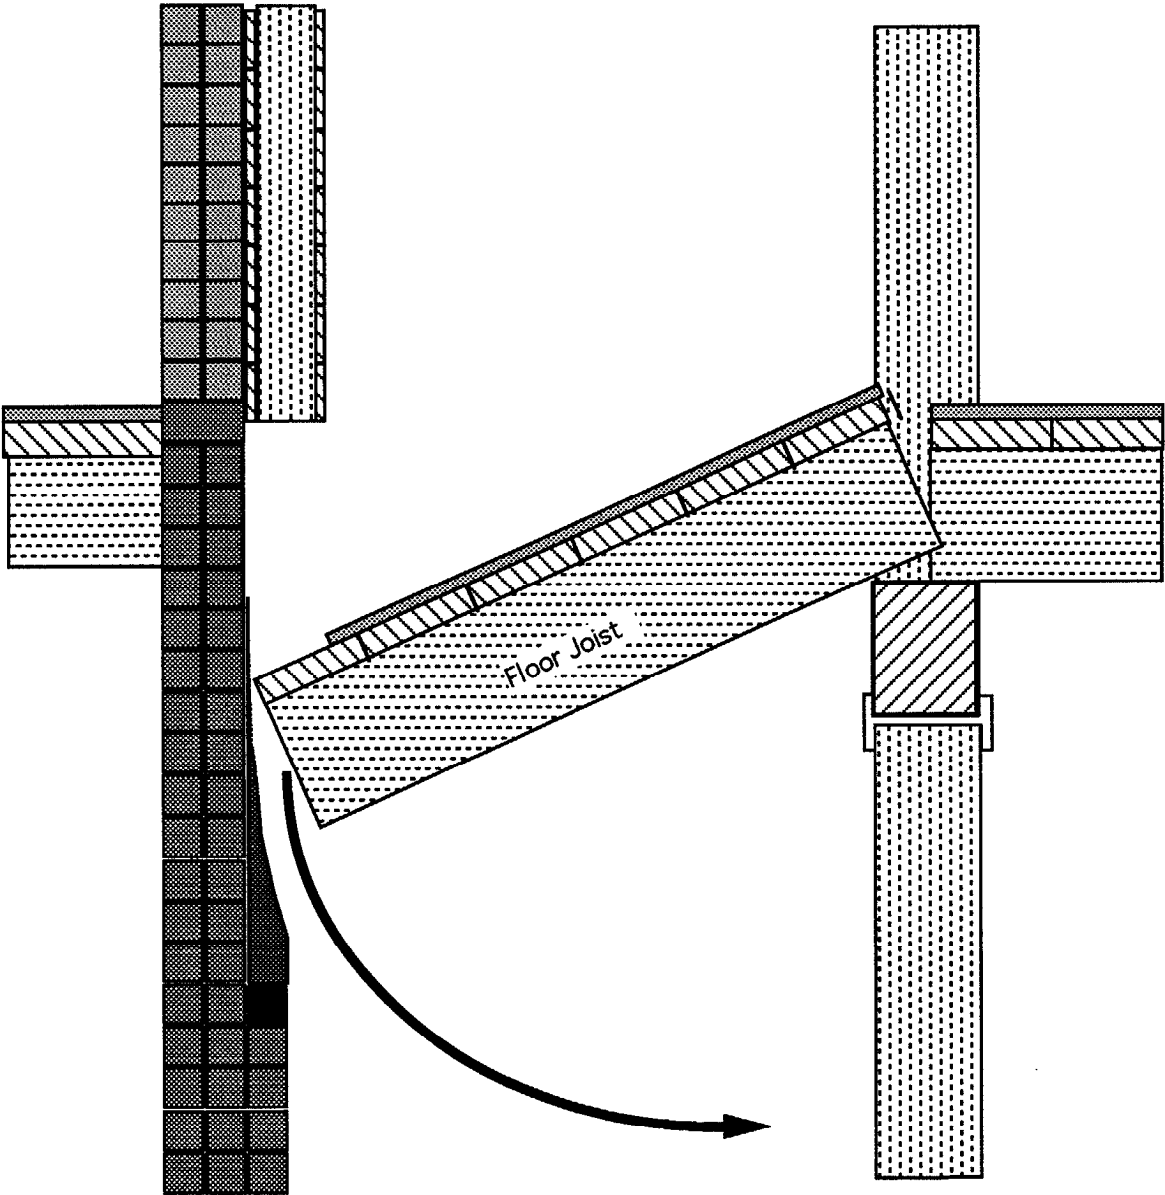
Figure 8

The hidden flaw in the structure was the support for the ends of the new floor joists along the north wall. The original roof was supported by a ledge that was incorporated in the brick wall. Because the new floor was four to five feet higher than the roof, a wood frame "pony wall" was fabricated from 2 x 4 inch wood members and erected on top of the ledge to support the ends of the new floor joists. This assembly did not have the inherent fire resistance of the more massive wood members and could be expected to fail rapidly under fire conditions. The failure of this assembly would release the ends of the floor joists and result in a sudden floor collapse.

Seconds later the building rumbled and flames erupted from the basement as the floor began to collapse. It appears that the "pony wall" failed, dropping the ends of the floor joists. Sections of the wood and concrete floor hinged down into the basement. The flames coming from

**FLOOR COLLAPSE MECHANISM  
UPON FAILURE OF PONY WALL**

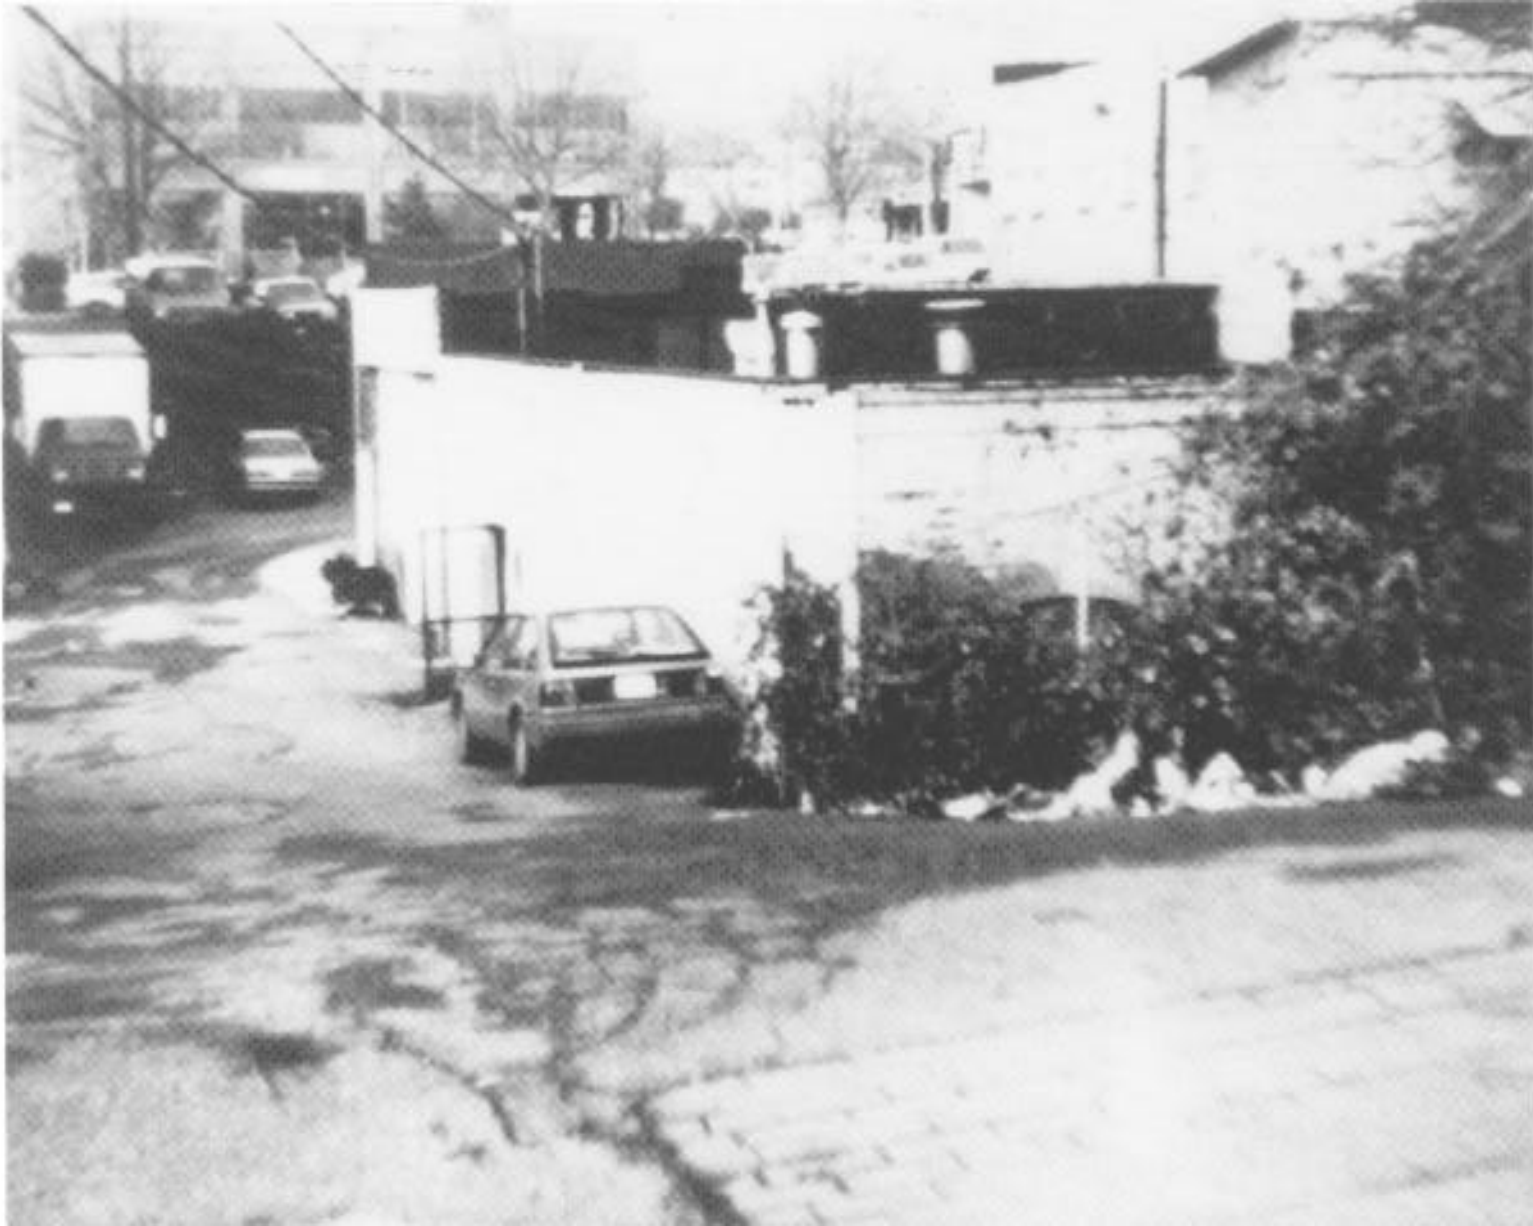
View from the rear (west side) of the Mary Pang building, looking from South Charles Street. The open door is the entrance to the bakery. The heavy vegetation between South Charles Street and the building can be seen on the right side of the picture.

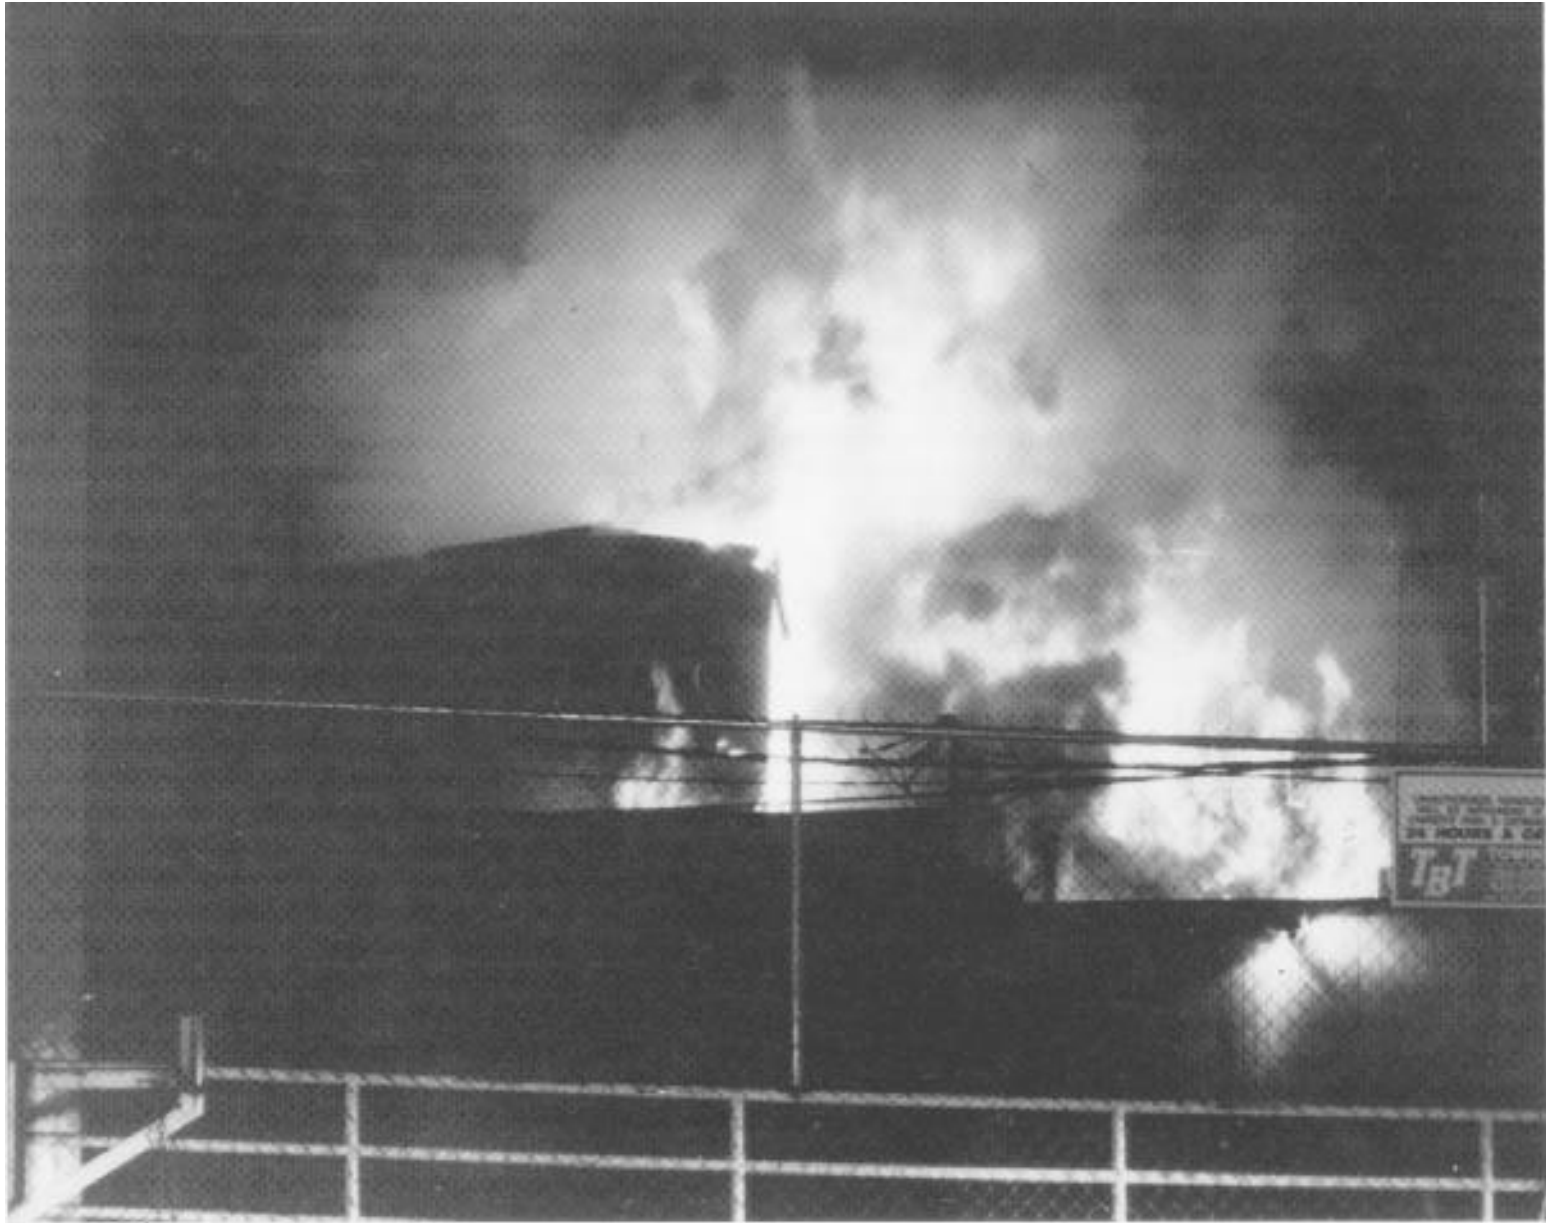
A large volume of fire was visible to units approaching from the west in the early stages of the incident. The outline of the lunchroom is visible next to the tallest flames.
